INSPECTION OF DAM AND RESERVOIR IN CERTIFIED STATUS

Name of dam Oroville Dam Dam No. 1-48 County Butte
Type of dam Earthfill Type of Spillway Gated Concrete Weir and Chute
Water is 12.53 feet above spillway crest and 95.67 feet below dam crest.
Weather Conditions Sunny, hot, calm
Contacts made Alex Samaan, Oroville Field Office
Reason for inspection Periodic Evaluation (2nd inspection)

Name of Dam Oroville Dam No 1-48

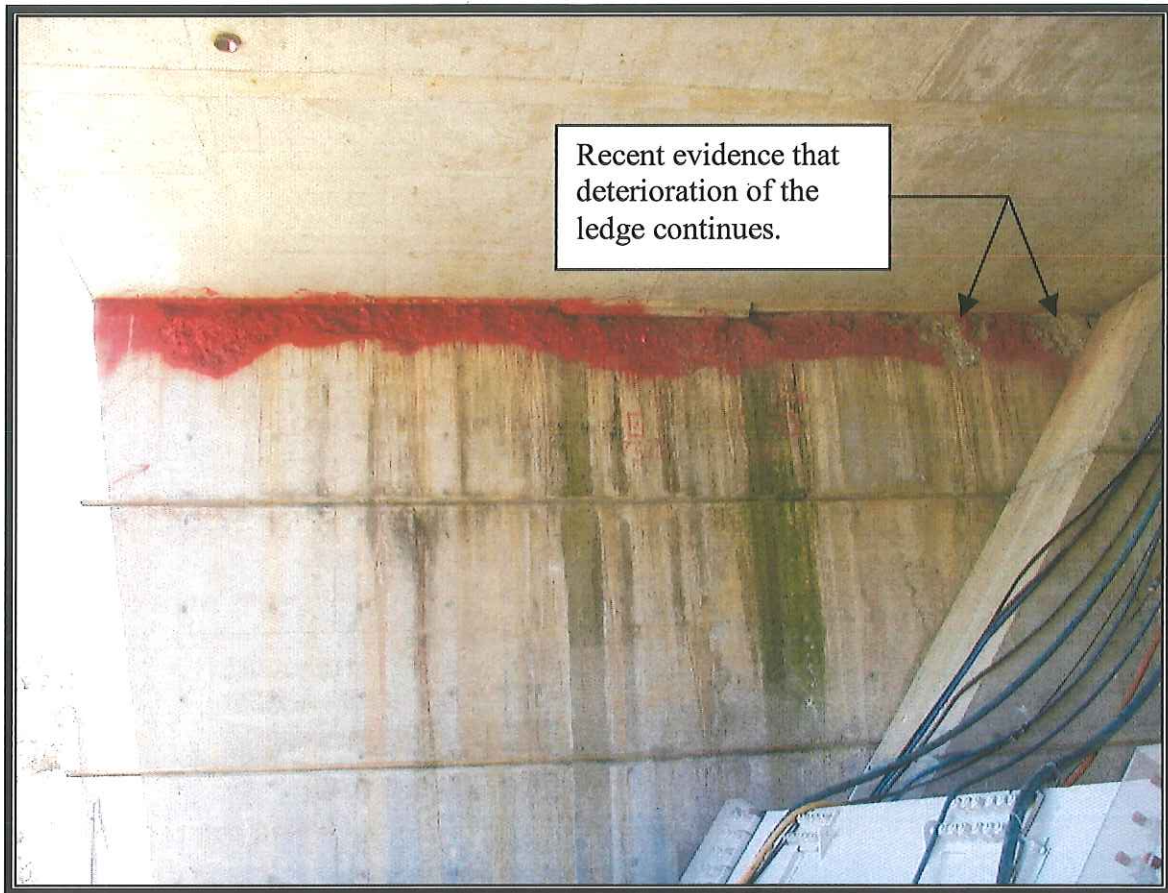
1. This view of the right bridge abutment shows recent deterioration of the bridge support. Consideration should be given to devising a repair.
